# Manhole Inspection Summary

Manhole # S43E\_\_011MH

Insp Date: **6/9/08 11:40 AM**

**Location** Address: **30 n bond st**

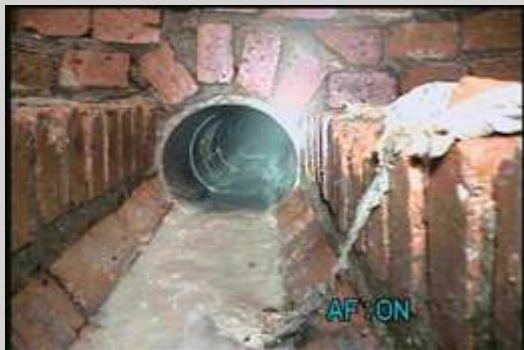
12 O'Clock Outflow

8 in. Circular Gravity Sewer  
Pipe Out @ 12 OClock

Pipe Material: Clay ☐ Pipe Lined

Invert Depth: 10.45 (ft.) Flow Characteristics: Fast

Infiltration: None Pipe Seal Cond: Unknown

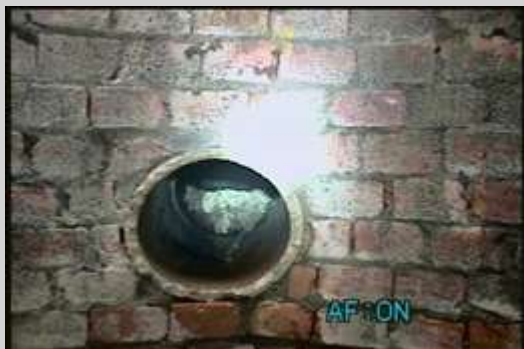
6 O'Clock Inflow

8 in. Circular Gravity Sewer  
Pipe In @ 6 OClock

Pipe Material: Clay ☐ Pipe Lined

Infiltration: None Pipe Seal Cond: Unknown

Drop Condition: Partly Clogged
